Association of resin infiltration and composite resin on the treatment of severe dental fluorosis.

Fluorosis infiltration – Case study of a young patient.

Resin Infiltration showing immediate esthetic improvement in non-pitted fluorosis.

Resin infiltration as a micro invasive treatment for fluorosis.

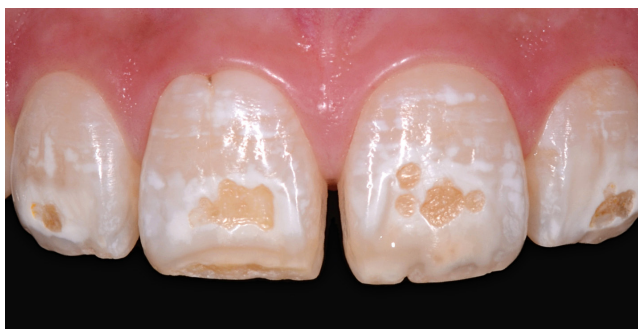
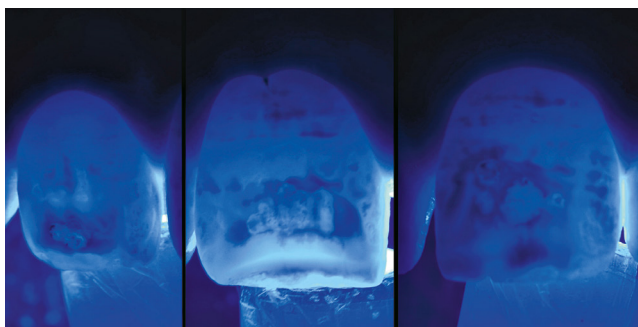
Fig. 1-4: Figures 1, 2 and 3 present different views of the clinical case in which the patient presents fluorosis (TF6). Observe that there are areas with diffuse and slight white opacities, areas with very opaque white opacities and areas that already present enamel loss and some discoloration. In Figure 4 transillumination was performed to check light transmittance through the enamel, that may be a useful diagnostic tool since the deeper the enamel hypomineralization, the more light is blocked. Some areas of the affected anterior teeth area were suggested to present deeper lesions, that may impair a more complete resin infiltration without some previous wear of the enamel.

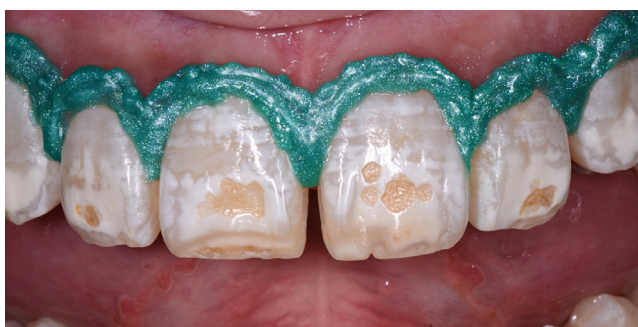
Fig. 5-8: After isolation of the operative field using lip retractors and a liquid dam to protect soft tissues (Fig. 5), Icon-Etch (hydrochloric acid) was applied on the surfaces for 2 mins (Fig. 6) aiming to remove the enamel surface layer and create access to the subsurface hypomineralized enamel (porous area). In Figure 7 it is possible to observe the matt appearance after the acid etching. In Figure 8, a drop of Icon-Dry (alcohol) was applied on the etched surfaces. After a few seconds, it is possible to see that some areas around the enamel pitting kept very white and opaque. This »optical test« after etching may be useful to indicate areas in which a more pronounced enamel wear is needed to create access to the hypomineralized layer. This extra step may be performed with repeated acid etchings or, in deeper lesions, with air abrasion or rotary instruments.

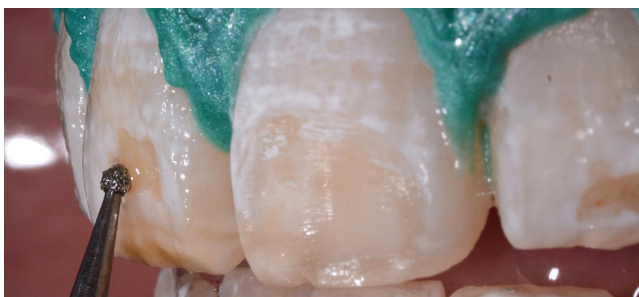
↗ Fig. 9

↗ **Fig. 9-12:** In this case we opted for diamond burs to wear the surface. Localized preparations were performed, removing the superficial part of the more affected enamel and areas of discoloration (where enamel pitting was already present) (Fig. 9). Then, Icon-Etch was applied once more for 2 mins (Fig. 10). Figure 11 shows the aspect after localized enamel wear and acid etching. It possible to see that there are still whitish areas that could be infiltrated. After etching Icon-Dry was dropped onto the surfaces (Fig. 12). Observe the more uniform aspect after alcohol application, indicating that a better access to the porous areas was achieved. Once the result was good, Icon-Dry was left for 30s and surfaces thoroughly dried.

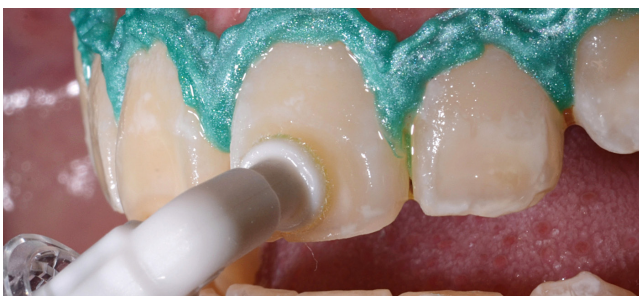
↗ Fig. 13

↗ **Fig. 13-16:** Icon-Infiltrant (the low-viscosity resinous infiltrant) was applied according to manufacturer's instructions (3 min, excess removal, light-curing; 1 min, excess removal, light-curing) (Fig. 13). In Figure 14 it is possible to see the aspect immediately after infiltration in which a uniform color was achieved and most of the whitish opacities were adequately masked. This uniform substrate eases composite resin stratification and improves final result since there is no need for masking white spots with opaque composites. Areas of worn enamel and previous enamel pitting where restored using only body and enamel shades (Fig. 15). It is interesting to say that after resin infiltration, if the surface was not contaminated, it is not necessary to apply an adhesive. Methacrylate-based composites effectively adhere to the infiltrant [6]. Figure 16 shows that tooth anatomy was correctly recovered. After composite resin application a careful finishing and polishing procedure was performed on the infiltrated and restored surfaces using abrasive disks, rubber cups and polishing pastes.

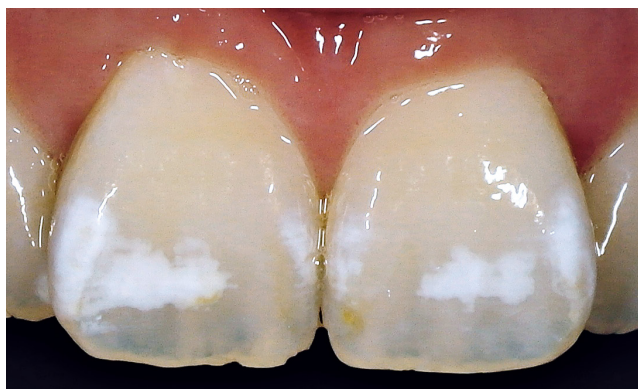
Fig. 1: Frontal view of the white spots 11, 21.

As part of a routine examination our patient reported an increasing urge to do something about the white spots on her anterior teeth (Fig. 1). After weighing various therapy options, it was jointly decided that infiltration was the treatment of choice [1].

In terms of the localization, form, and patient's history, the white spots on the labial surfaces of teeth 11 and 21 are classified as fluorosis with severity 0.5 (community fluorosis index according to Dean). Masking of the white spots using infiltration is based solely on altering the refractive index near the whitish opacities. Healthy enamel has a refractive index (RI) of 1.62. The different refractive index at the margins causes light to scatter which gives the lesion a whitish appearance [6]. Regardless of whether the porosities are caused by incipient caries or a mild fluorosis, in the initial stage they appear as whitish staining to the human eye due to the lower refractive index. Infiltration of this area will change the refractive index and mask the opacities. Most of the data on infiltration in the labial surfaces of the anterior teeth are from patients following orthodontic multiband treatment. The resultant white spots can be very easily and permanently eliminated using infiltration [7, 8].

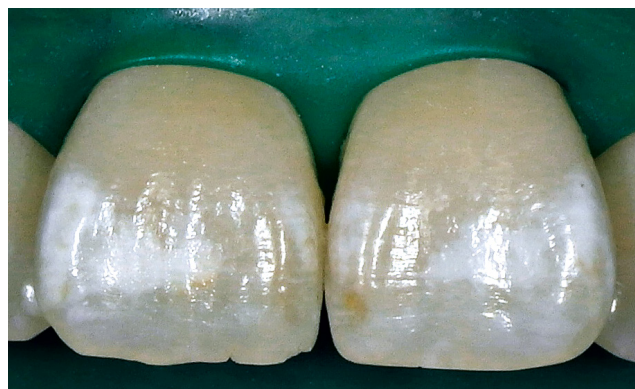
Fig. 2: Firstly, the teeth should be cleaned or (as in our case) a professional dental cleaning should be done. A protection of the mucous membranes using a dental dam is performed.

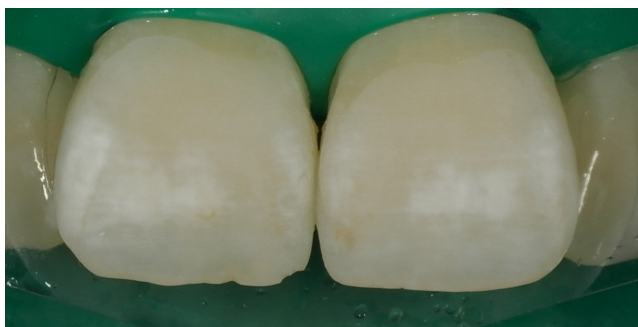
Fig. 5

Fig. 5: The Icon-Infiltrant was then applied and left on for three minutes, the excess was removed, and this was followed by light curing. This procedure was repeated with the option of shortening the application time (one minute).

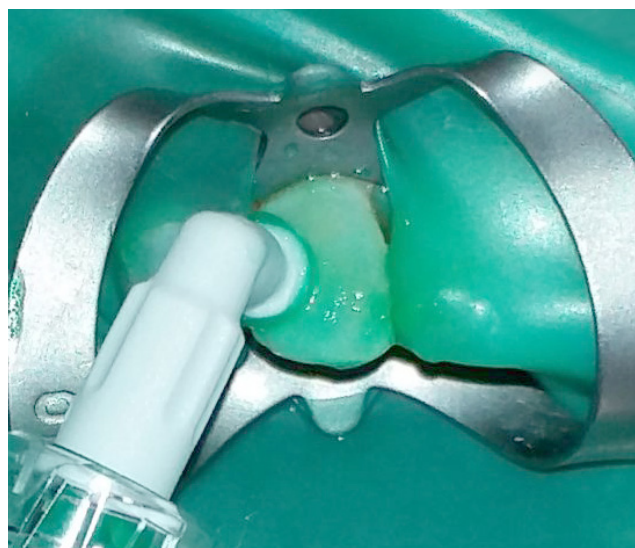
Fig. 2

The tooth represented in this clinical case is #12, which was isolated with rubber dam and the white opacity covering the whole tooth is visible in the pre-operative clinical picture (Fig. 1). This was followed by application of Icon-Etch for 2 minutes (Fig. 2).

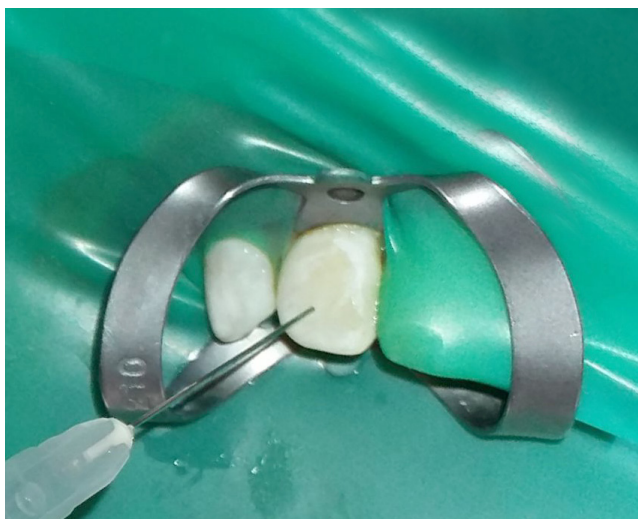
Fig. 3

Icon-Etch was washed off for 30 seconds and tooth was dried with oil free air. Etching was repeated again for 2 more minutes. Next the drying agent (Icon-Dry) was applied for 30 seconds (**Fig. 3**), which then evaporated leaving the accentuated pores making it easy for infiltrant to seep in. Lastly the infiltrant was applied (**Fig. 4**) and was left in place for 3 minutes followed by light curing the infiltrant for 40 seconds (**Fig. 5**) and a repetition of infiltrant application for 1 more minute. Immediate improvement in esthetics and good patient satisfaction was observed (**Fig. 6**).

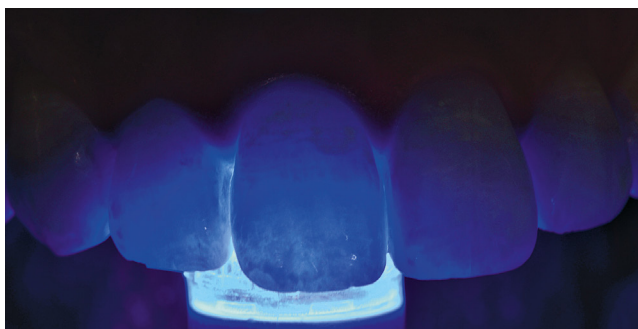
Fig. 3: To evaluate the depth of the affected enamel a clinically useful tool is to perform transillumination. Specific equipment or even a simple light curing unit can be positioned on the lingual surface and commanded to emit light. When the transmitted light is not or is only slightly blocked by the opacities, the lesions (enamel porosities) are shallow and the probability of less invasive therapies to be effective is higher. In the present case, this was the situation and the fluorotic lesions were judged shallow, indicating a good prognosis for resin infiltration.

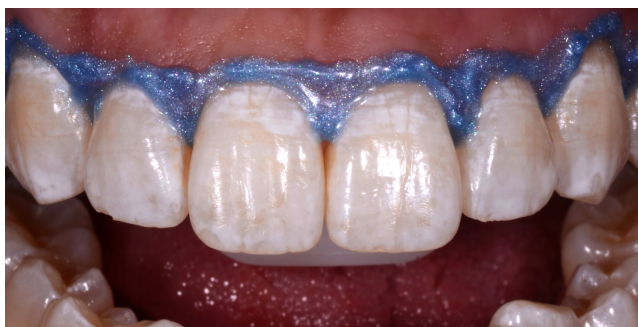
Fig. 4: Next step is isolating the teeth that will be infiltrated. Field isolation and protection of the gingival tissue can be obtained using rubber dam or a liquid light-cured resin dam (Top Dam, FGM, Brazil) together with cheeks, lips and tongue retractors. While the liquid dam is usually faster and easier to apply, rubber dam may present a more intense gingival retraction, that may improve results in the cervical area. In this case, the liquid dam was selected and carefully applied to cover as little enamel as possible.

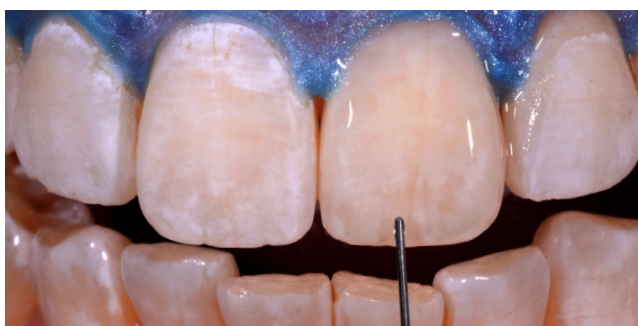
Fig. 5

In the present case, in Figure 5, it is possible to observe the aspect after a single etching procedure. Since the opacities were still very visible it was decided to repeat the etching step once more. In Figure 6, it is possible to see the difference between the aspect after one and two etching steps as a drop of Icon-Dry was applied onto the etched enamel surface. Since the result was satisfactory, the ethanol was let on the surface for 30 s to promote a thorough desiccation of the enamel, followed by air-drying.

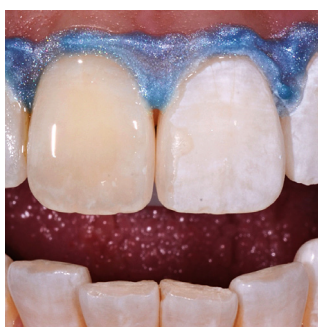
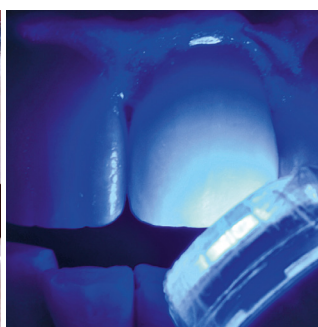
Fig. 7-8: On the etched and dry enamel the low-viscosity infiltrant (Icon-Infiltrant, DMG, Germany) is applied and should remain for at least 3 minutes to achieve maximal infiltration depth into the porosities of the hypomineralized enamel. In Figure 7 it is possible to observe the aspect after infiltrant application on the right upper teeth, while the left have not received the resin yet. When all teeth received the infiltrant and the 3 minutes waiting period was respected, obvious excess can be removed using a gauze and light-curing is performed (Fig. 8). It is paramount to execute a thorough polymerization using adequate irradiance and exposure time (40 seconds per tooth). A second application of the infiltrant should be performed for 1 minute followed by excess removal and light-curing.

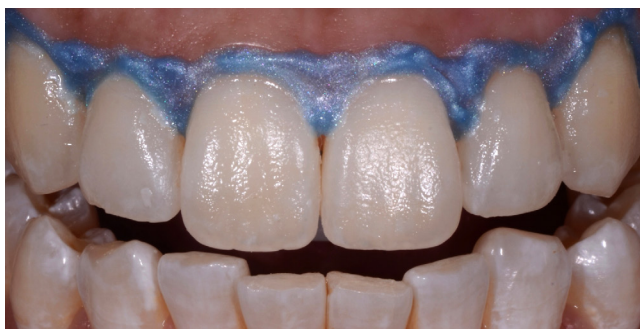
↑ **Fig. 9:** It is possible to see the immediate aspect after infiltrant polymerization. It is normal to observe a shiny and irregular appearance due to excess of the infiltrant covering the surface. These material is easily removed with polishing instruments as abrasive disks, spirals or rubber cups.

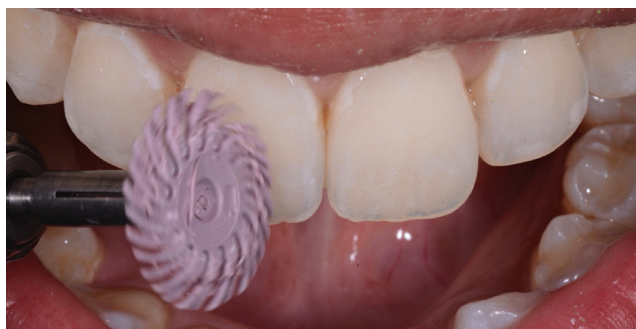
↑ **Fig. 10:** In the present case polishing was performed using disks and spirals (Sof-lex, 3M, USA).

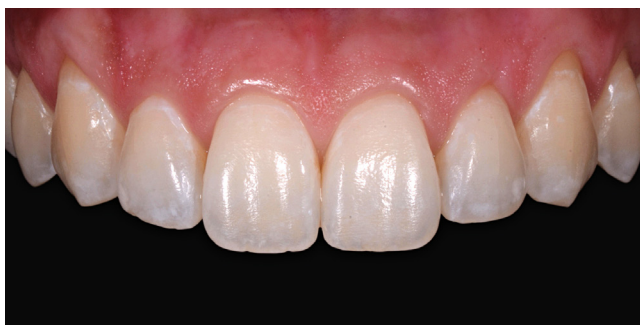
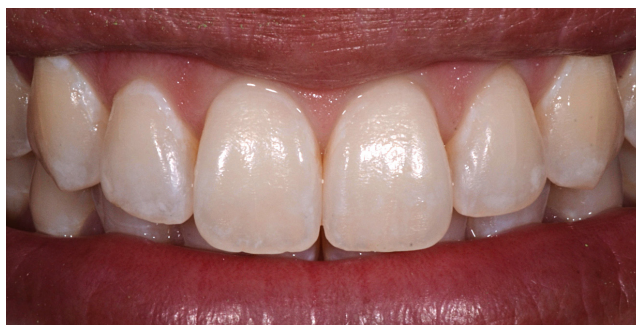
After polishing, the result of the treatment is shown on Figure 11 and 12. Almost all white opacities disappeared, indicating a satisfactory infiltration of the fluorotic enamel.

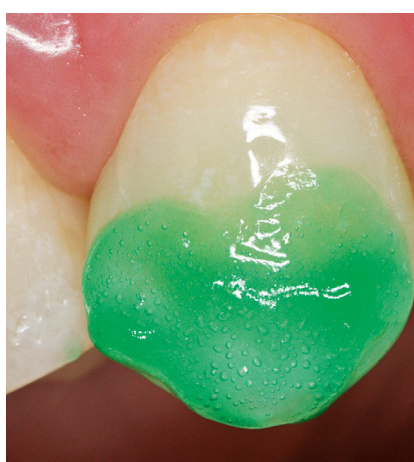
Fig. 2: After cleaning with prophylaxis paste, the affected vestibular area was initially conditioned for 2 minutes with 15% hydrochloric acid gel (Icon-Etch, DMG). At this juncture, the more heavily mineralized surface layer was removed. This shows fewer pores as a result of remineralization processes than the lesion underneath and would thus prevent the infiltrant from penetrating. After 2 minutes, the etching gel was water sprayed off and the lesion carefully dried.

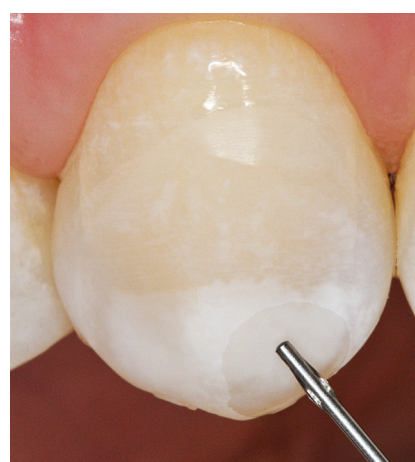
Fig. 3: To achieve further deep drying and at the same time check whether sufficient abrasion of the surface layer was achieved, ethanol (Icon-Dry) was subsequently applied to the lesion. Due to penetration of the ethanol into the lesion's porosities, similar to the later infiltration with resin, the light refraction within the caries was reduced, making the lesion appear less whitish-opaque. When this effect can be observed in the first 2-5 seconds after application of the ethanol, the surface layer is sufficiently abraded to guarantee a quick and complete infiltration.

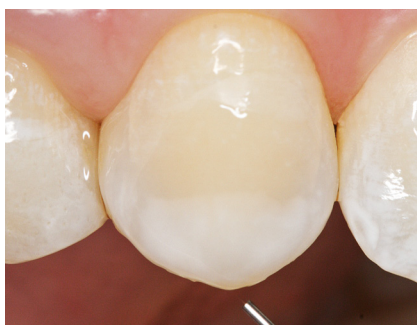
Fig. 4

Fig. 4: If the color change is slower, this most often indicates that the surface layer has not been eroded completely. In this case, the lesion should be etched again. In the present case, the lesion was etched again for 2 minutes, the etching gel subsequently sprayed off, the lesion dried with compressed air and ethanol applied once again. **Fig. 5:** At this juncture, an instant (< 2 seconds) disappearance of the lesion's opacity could now be observed, which indicates adequate removal of the surface layer. In preparation for the subsequent infiltration, the ethanol was vaporized with compressed air and the lesion consequently dried thoroughly. **Fig. 6-7:** The infiltrant (Icon-Infiltrant, DMG) was applied in the subsequent step. It could also be observed here how the resin penetrated the lesion and adapted its color to the surrounding tooth enamel. **Fig. 8:** Even though the lesion was fully masked after a few seconds, the excess resin was only removed from the lesion surface with a foam pellet after 3 minutes. **Fig. 9:** The resin then underwent light-curing for 40 seconds. To compensate for the infiltrant's polymerization shrinkage, the resin was applied again and cured again after 1 minute (no illustration). Thanks to the oxygen inhibition of the polymerization of the resin surface layers, a thin raw unpolymerized resin layer remains on the enamel surface. This should be removed by polishing. In the current case, polishing was carried out with polishing disks (Sof-Lex, 3M Espe). **Fig. 10:** The final result on tooth 13 was very satisfactory immediately after the treatment. The remaining teeth (12-23) were thus subsequently treated as described above and showed complete masking of the fluorosis immediately after treatment.

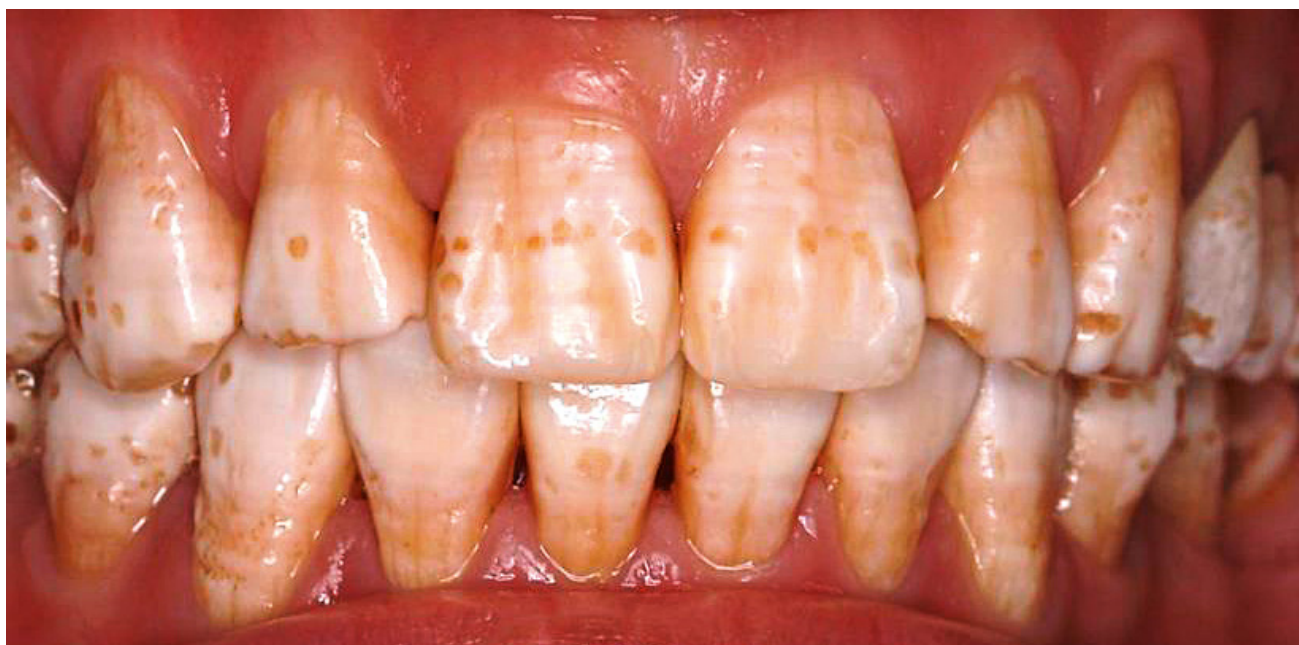
Fig. 1: Before treatment. The full dentition was mottled and defected. We chose at-home bleaching first to improve the color of the teeth.

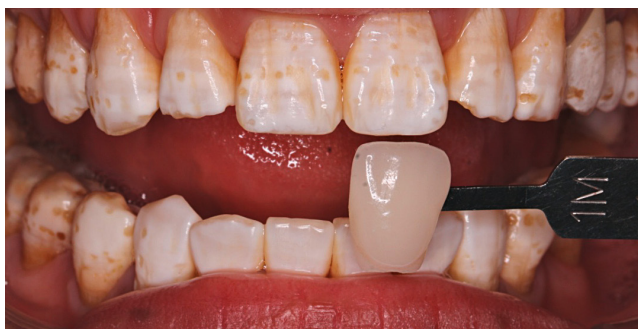
➤ **Fig. 2:** After the comprehensive clinical examination the colorimetric analysis was done and the color of the teeth was recorded. We made individual bleaching tray for the patient and gave the instructions of at-home bleaching and oral health instruction. After using eight units of Opalescence PF 10 % for four weeks, the color of teeth improved dramatically. We began the Icon resin infiltration treatment.

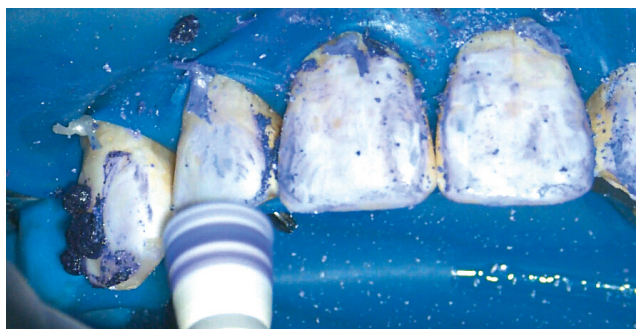
➤ **Fig. 3:** The use of rubber dam is essential when Icon is applied. After cleaning the teeth, rubber dam was performed to isolate the operative site from the rest of the mouth. Tooth cervix was tied off with dental floss. Applied Opalustre grinding paste, which is 6.6 % hydrochloric acid slurry that contains silicon carbide microparticles, on the tooth surface. Polish for 60 s with low speed dental handpiece and rubber cup under the middle pressure. Rinse the grinding paste and evaluate the effect.

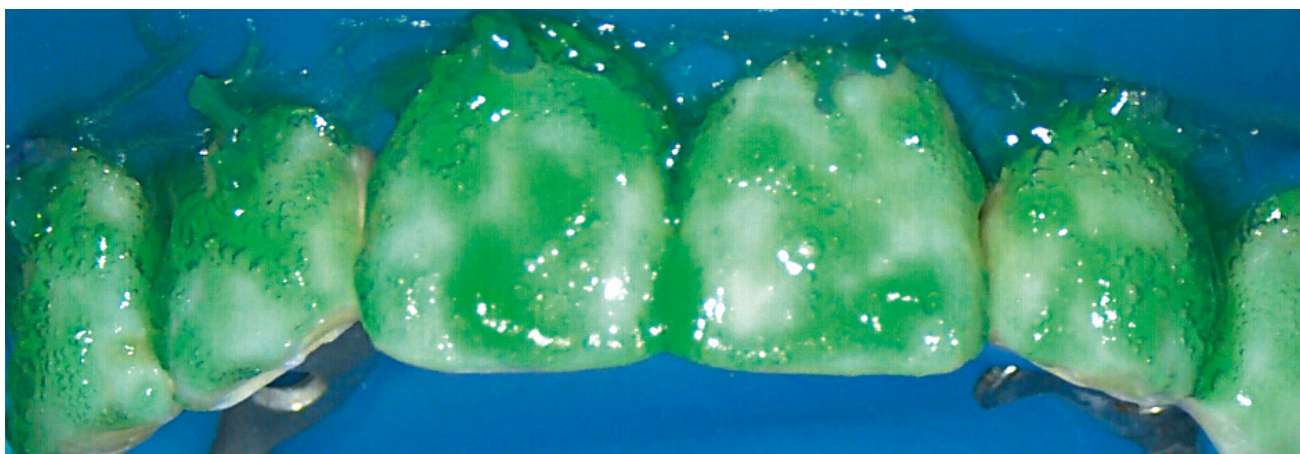
➤ **Fig. 4:** Icon-Etch was applied for 2 minutes and sprayed with water and air for 30 seconds. Dry with oil-free and water-free air.

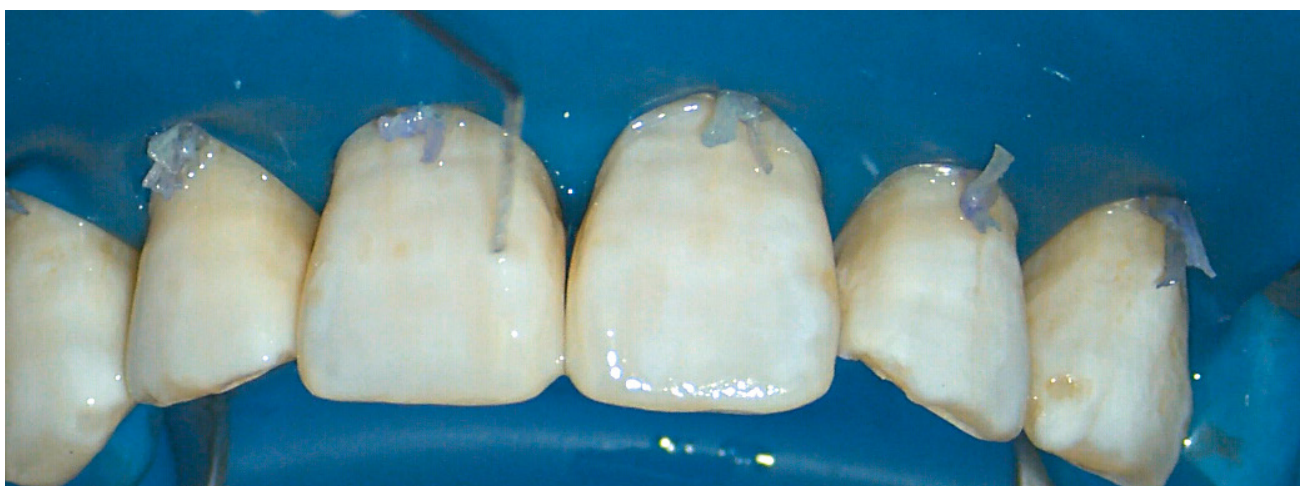
➤ **Fig. 5:** Screw the application tip onto the Icon-Dry syringe, apply an ample amount of material onto the lesion, and allow to set for 30 s. In this step a preview of the final result is shown. When wetted with Icon-Dry, the whitish-opaque coloration on the etched enamel should diminish. The result of the visual check after the first etching showed that the second etching is necessary.

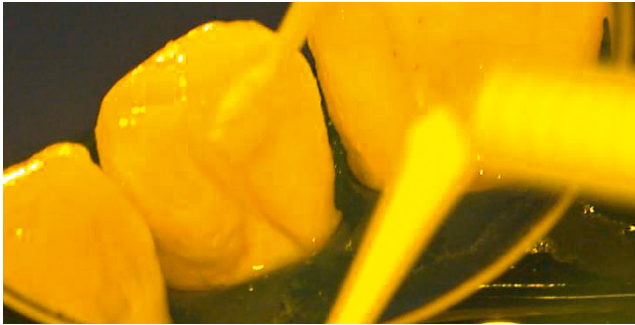
↗ Fig. 8

↗ **Fig. 8:** Use ENA HRi esthetic restorative system (UD3+UE3) to fill enamel defects.

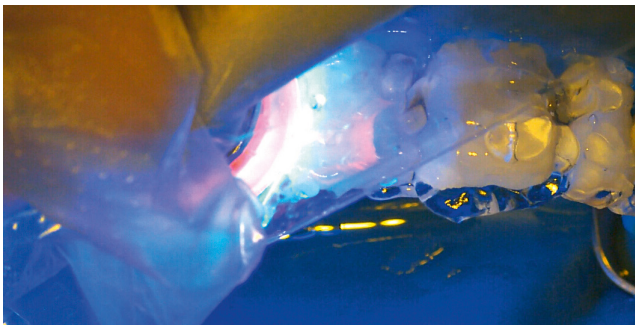
↗ Fig. 9

↗ **Fig. 9:** Screw a new Smooth Surface-Tip onto the Icon-Infiltrant syringe, repeat the application, and allow to set for 1 minute. Remove excess material with a cotton wad and dental floss. Apply Antioxidant and light-cure palatal side firstly, then labial side.

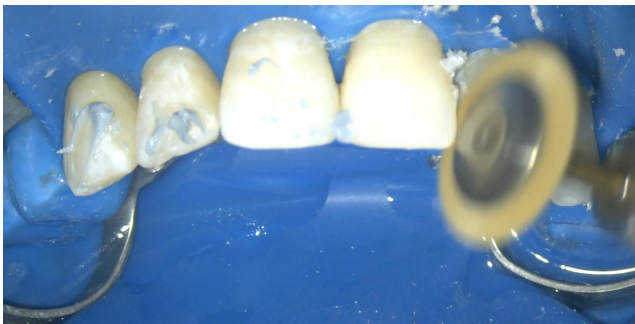
↗ **Fig. 10:** Polish the teeth surface with wool polishing wheel and ENA SHINY A,B,C paste.

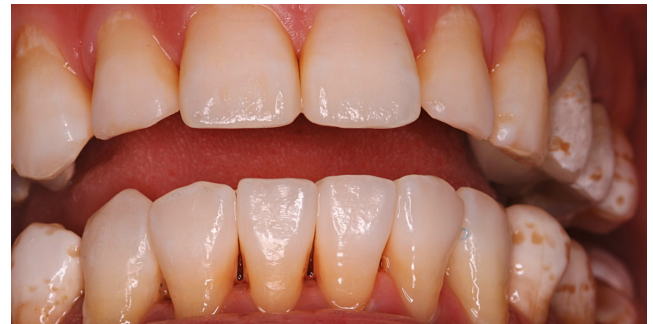
↗ **Fig. 11:** Immediately after the removal of the rubber dam the esthetic of the upper anterior teeth are visible. The mandibular anterior teeth get the effective result with the same steps. Immediate postoperative esthetics.

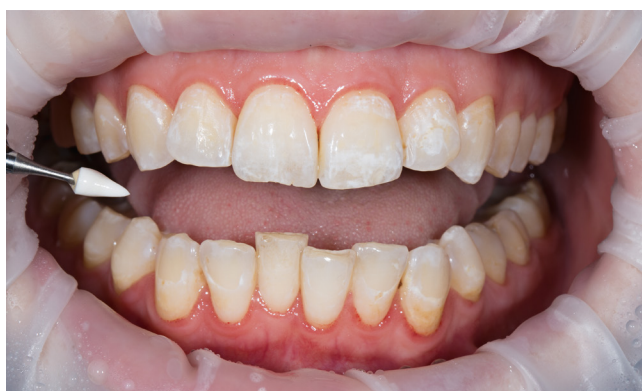
Fig. 1: Start by applying an optragate to get the patients lips out of the way. Then take a white polishing stone and gently polish the enamel surface for a few seconds to get rid of the superficial biofilm on the enamel surface.

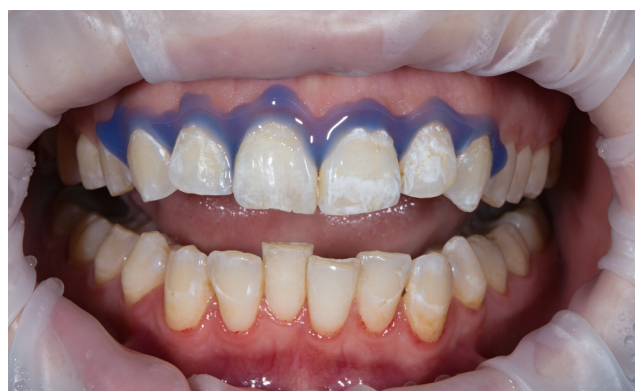
Fig. 2: Apply liquid rubber dam or classical endodontic rubber dam with ligatures to protect the gingiva.

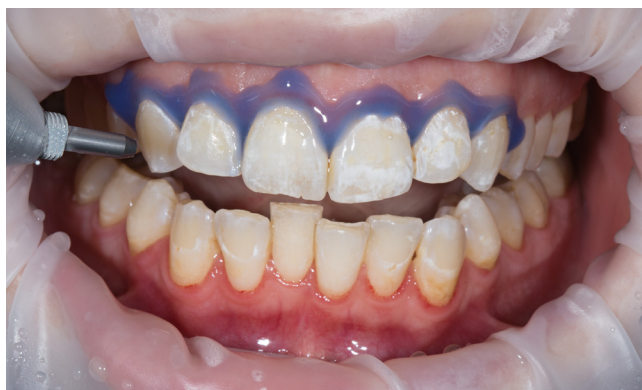
Fig. 3: Blast the white spots with white aluminiumoxide. This will enable better access to the body of the lesion. Blasting of the white lesions should only be done for 2-3 seconds and only once, with the blasting tip positioned approximately 1 cm from the enamel. After completion of this stage the white lesion should give away a matte appearance.

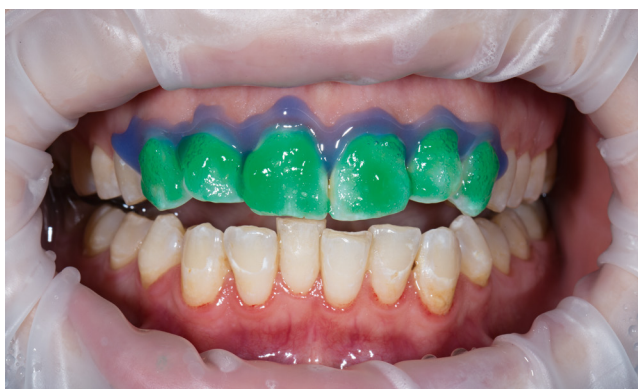
➤ **Fig. 4:** Apply Icon-Etch over the white lesions and rub it gently for a few seconds with a dry tip until the etch loses its glide and gives away a foamy appearance. Let the Icon-Etch rest on the surface for 2 minutes and then rinse it off with water for at least 30 seconds.

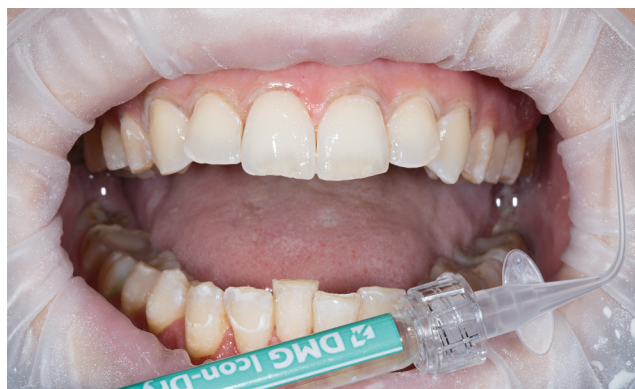
➤ **Fig. 5:** After careful rinse of the tooth surface, dry with oil-free and water-free air. Then wet the white lesion with Icon-Dry. What you want to see is either a complete temporary masking/disappearance of the white lesion when wetted or a fluctuation in the white color of the lesion when wetted with Icon-Dry. This indicates that the lesion is now accessible for the Icon-Infiltrant.

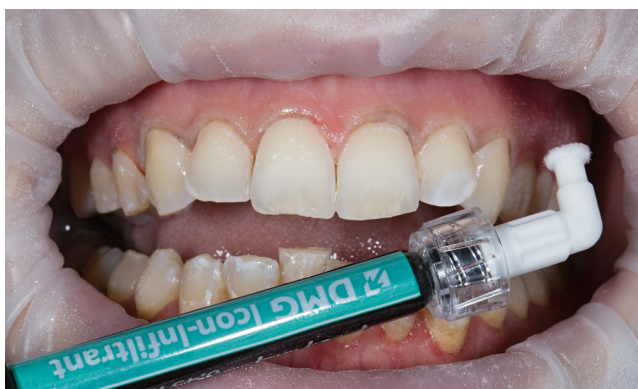
➤ **Fig. 6:** When the white lesion has responded well to Icon-Dry it is time to use the Icon-Infiltrant. Take your chair attached lamp away from the patient's teeth and apply Icon-Infiltrant on a dry enamel surface. Use rich amounts. Let it then infiltrate the surface for 3 minutes. Carefully air-dry the surface followed by flossing then light cure for 40 seconds. Repeat the process a second time, but with only 1 minute infiltration time.

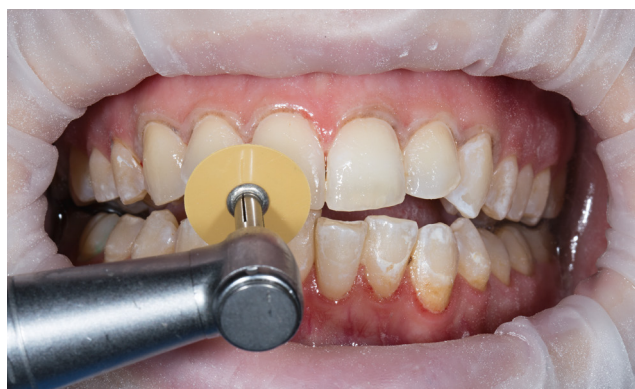
➤ **Fig. 7:** After the Icon-Infiltration process the enamel surface will present a matte appearance. To get a shiny and smooth surface use 3M polishing discs. Start with a light orange disc on a dry surface and carefully polish away any unevenness. Moreover, rinse the surface with water, air blast and finish the polishing process by using a yellow disc.

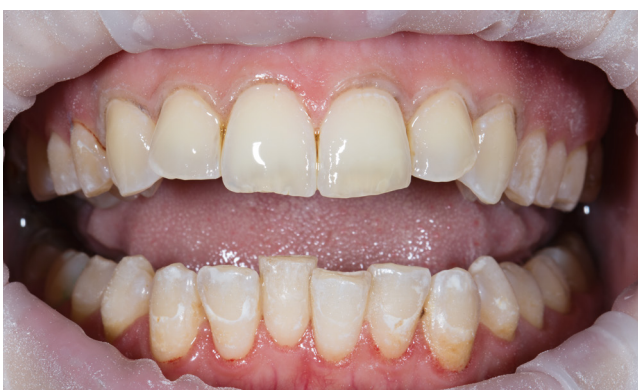
➤ **Fig. 8:** Final result.

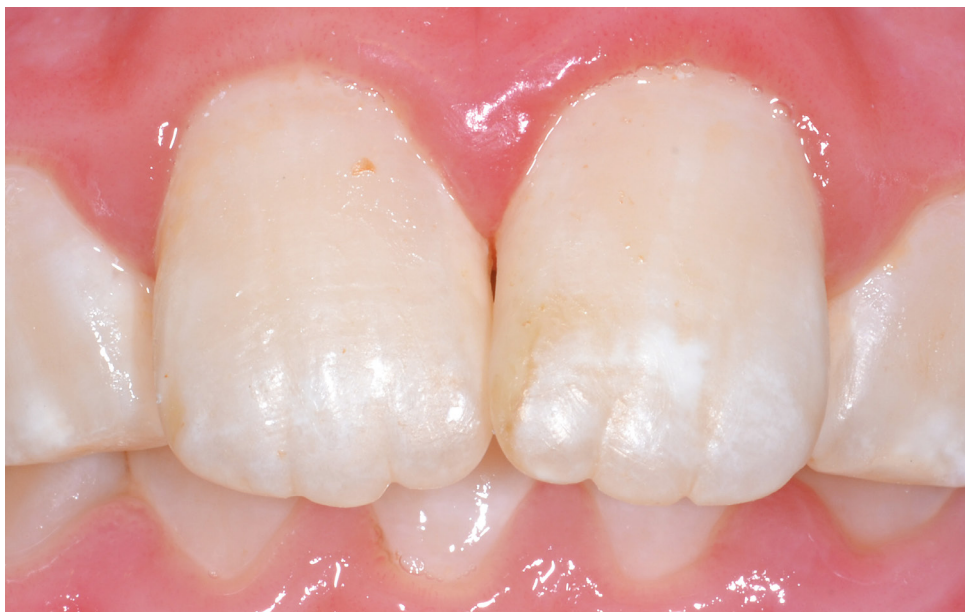
Fig. 1: Initial situation of the fluorotic spots before treatment with Icon. Especially the appearance of the teeth 21 and 11 were esthetically compromising.

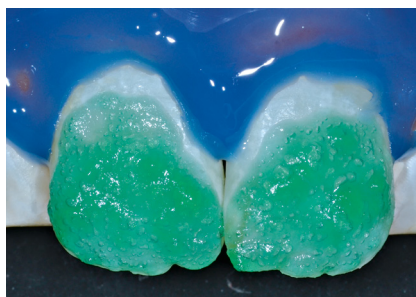
Fig. 3

Fig. 2: After polishing the teeth with pumice the resin barrier Opaldam Green (Ultradent®) was applied in order to isolate the working field and to protect the gingiva which both is mandatory when using Icon. **Fig. 3:** To condition the surface Icon-Etch was applied for 2 minutes. The etching gel was removed with water spray for 30 seconds and the surface was dried. The etching step was repeated 4 times. Especially with fluorosis it is often necessary to repeat the etching step several times to gain sufficient access to the lesion body. **Fig. 4:** In the next treatment step Icon-Dry was applied for 30 seconds. Immediately after the wetting with Icon-Dry the operator gets a preview of the masking effect. If the lesions do not diminish the etching step should be repeated. After 30 seconds the surfaces were thoroughly dried with oil free and water-free air.

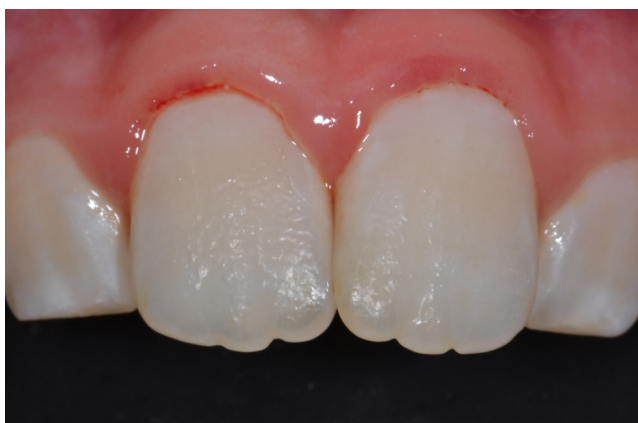
Fig. 5

Fig. 5: Next Icon-Infiltrant was applied and it was set for 6 minutes because of severe fluorosis diagnosis. Excess material was removed with a cotton wad and dental floss before it was light cured for 40 s. This infiltrant step was repeated letting the infiltrant set again for 3 minutes before excess removal and light curing. Polishing was performed with Flairesse medium (DMG®) and Enamel Shiny Micerium polishing kit (Micerium s.r.l.). The fluorotic spots on both central front teeth are completely masked. **Fig. 6:** Clinical situation 3 months after Icon treatment. The situation is stable, the lesions on the teeth 21 and 11 are masked completely.

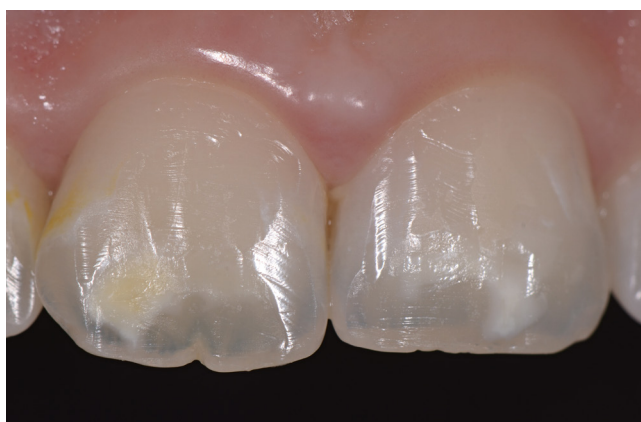
➤ **Fig. 1:** Initial situation with two lesions due to trauma on teeth 11 and 21 (white lesion on 21 and slightly yellow on 11). The third incisal portion of teeth is concerned with a high translucency of the edge. As the lesion appears relatively deep, we know that we need to infiltrate in depth. So we eliminate a very thin layer of enamel with the bur.

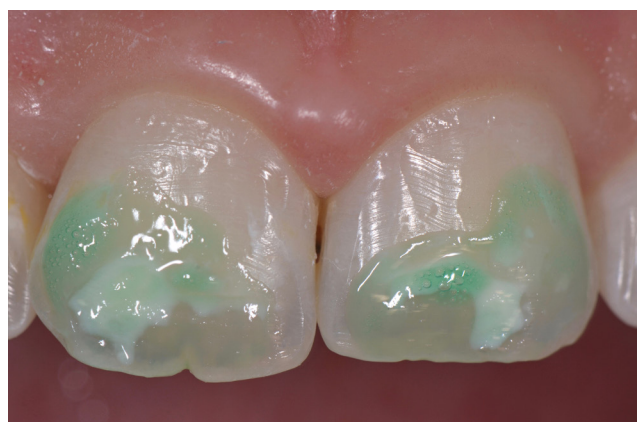
➤ **Fig. 2:** First application of Icon-Etch.

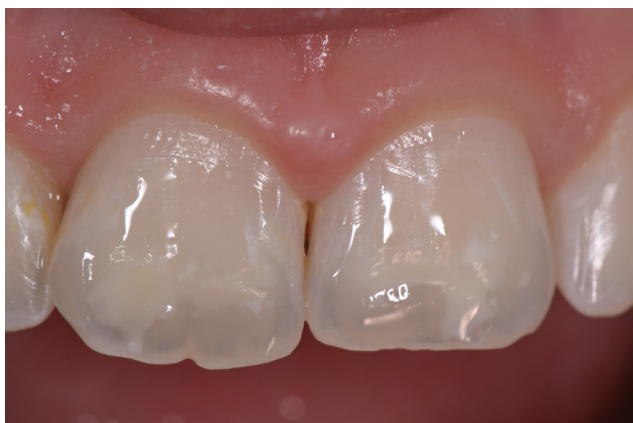
➤ **Fig. 3:** After rinsing, drying and application of Icon-Dry, we note a slight masking of the lesions. But not enough to infiltrate.

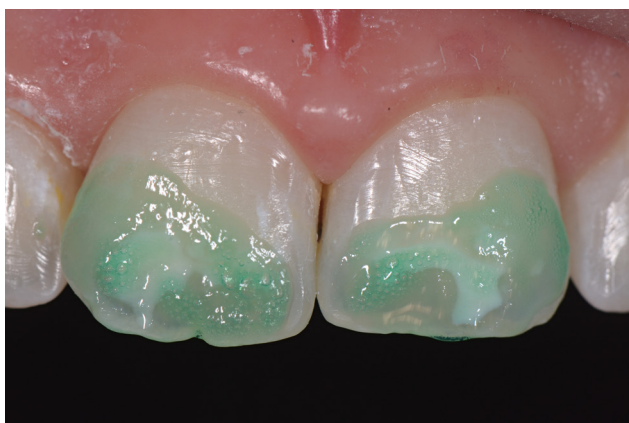
➤ **Fig. 4:** Second application of Icon-Etch

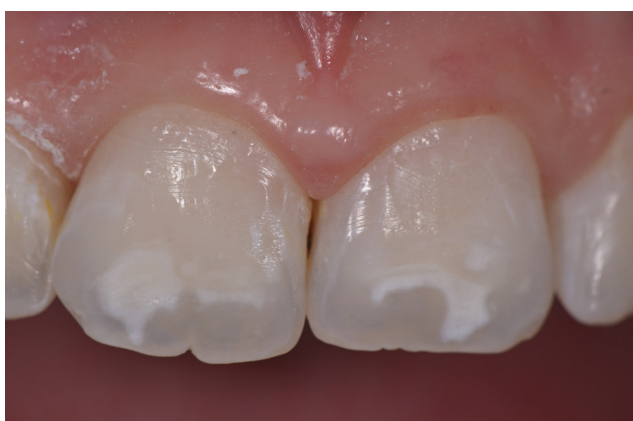
➤ **Fig. 5:** After rinsing and drying.

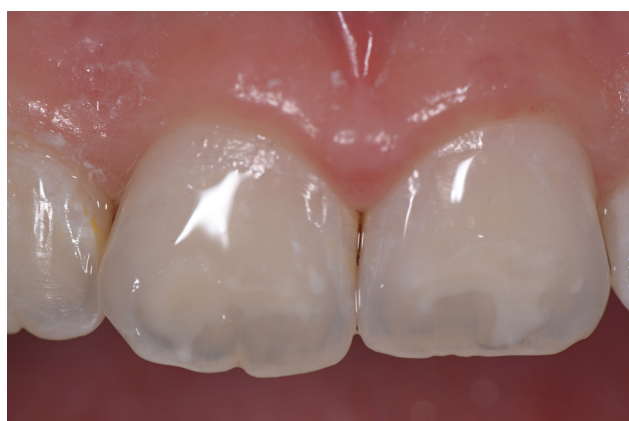
➤ **Fig. 6:** Icon-Dry allows a partial masking of the lesion. That shows that ethanol can infiltrate the porous lesion. We know that Icon-Infiltrant could infiltrate too.

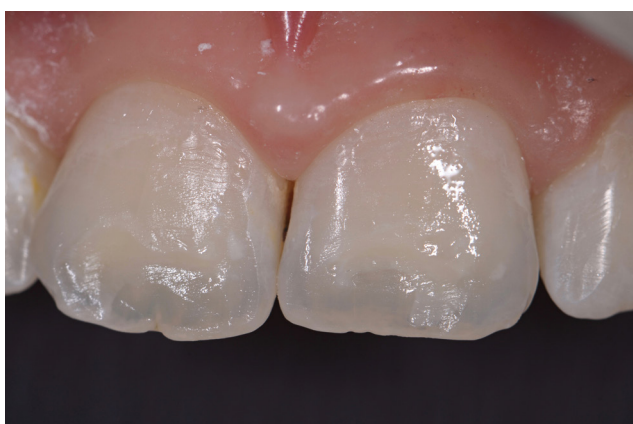
➤ **Fig. 7:** After infiltration with Icon-Infiltrant and light curing. The masking is efficient.

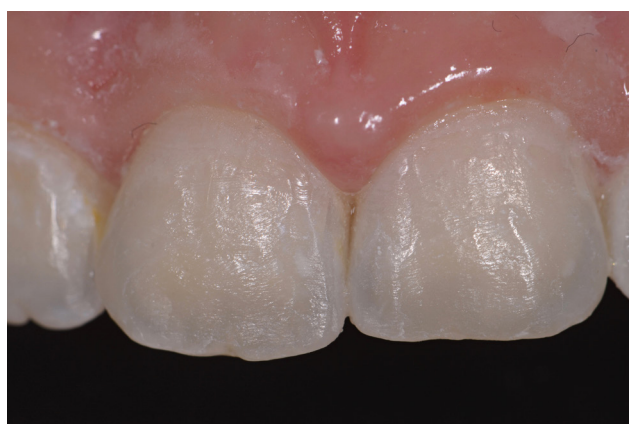
➤ **Fig. 8:** A small amount of enamel composite is sufficient to compensate the very small loss of substance of enamel due to the combination of bur and acid erosion. The lesions are not visible anymore.

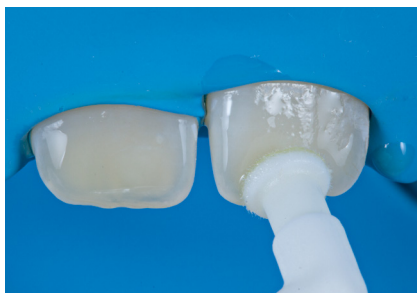
Fig. 10

Fig. 10: Application of the Icon-Infiltrant. An ample amount of Icon-Infiltrant should be introduced onto the lesion site and should sit for 3 minutes with the operatory light turned off.

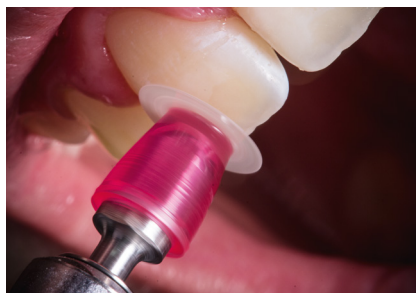
Fig. 11

Fig. 11: Excess resin should be gently removed using slow speed disks or rubber cups, leaving a polished enamel surface.

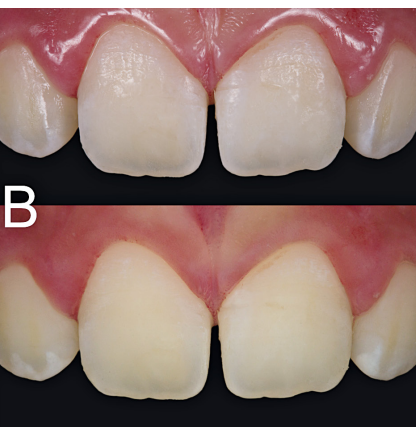
Following a 30-second application of absolute ethanol, the lesion on tooth 11 appears to be masked well. A comparison of the first (A) and second (B) rounds of Icon-Dry applications. For each step, the upper photo shows the dried lesion and the lower one shows the dramatic masking effect created by absolute ethanol. After two rounds of etching and drying, it is evident that an additional etching step will not be required.
